Clashindarroch II Wind Farm
Environmental Impact Assessment
Bat Activity Survey 2019

Figure 9.14

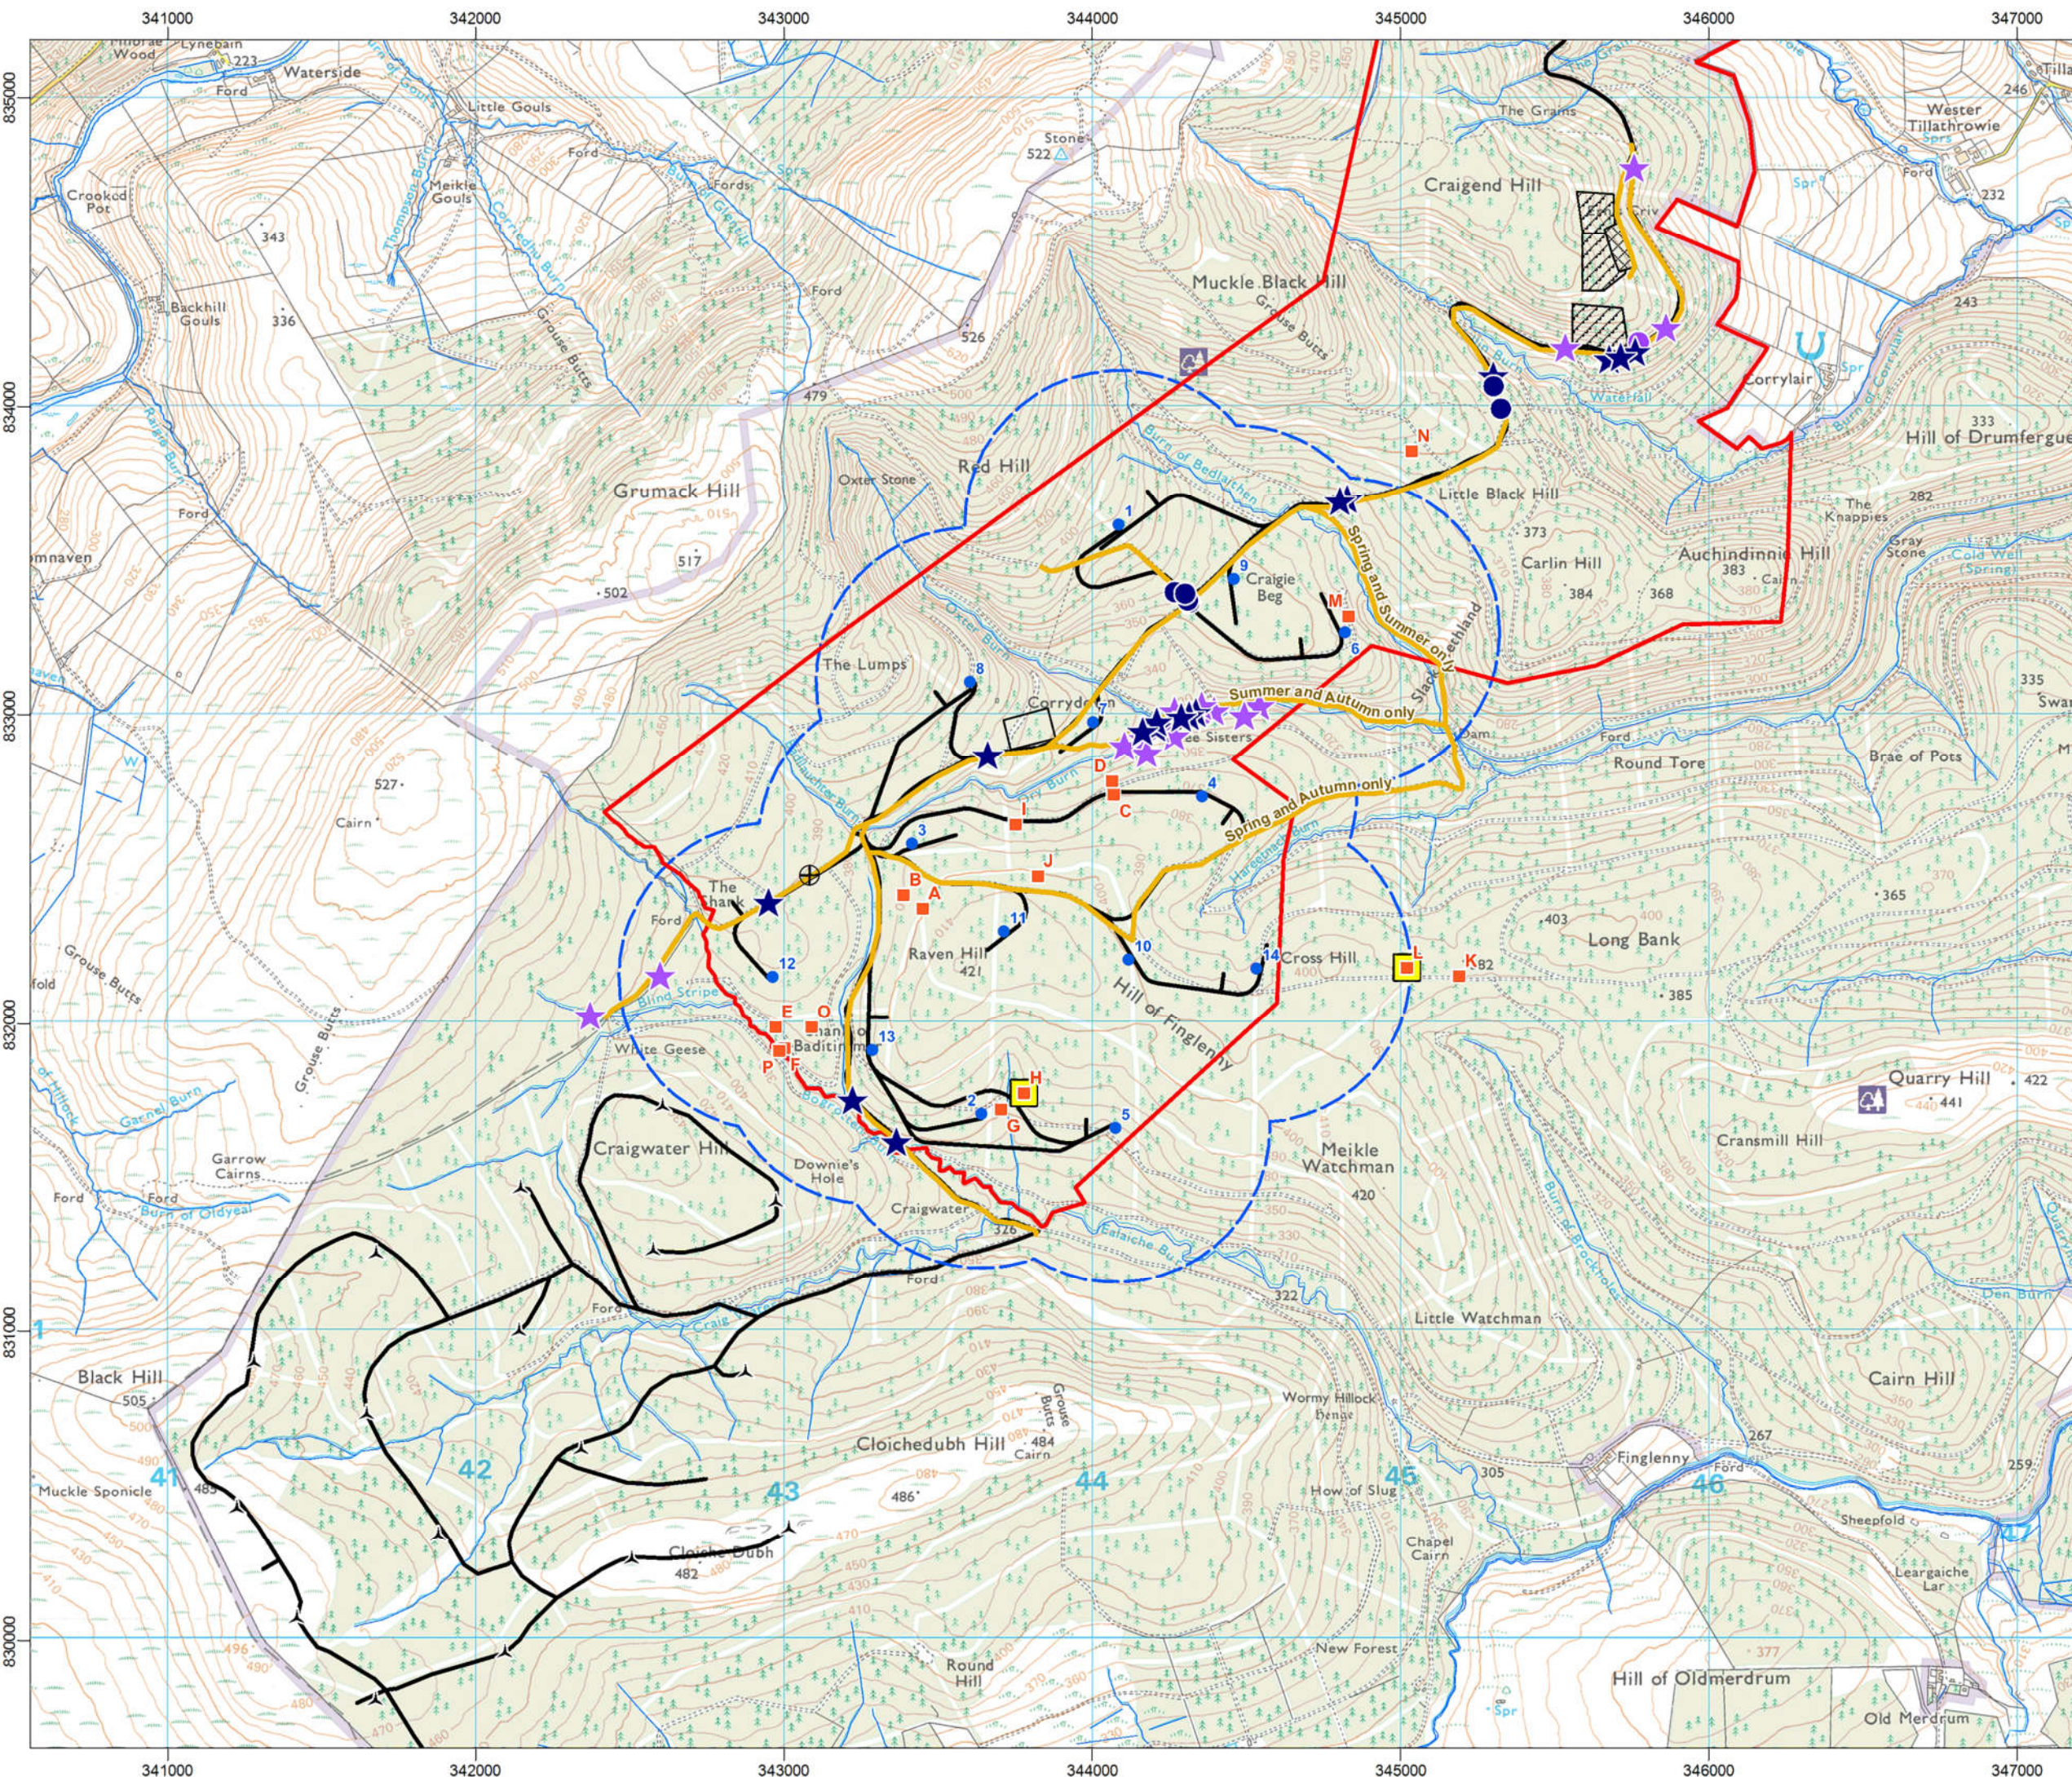
- Legend**
- Site Boundary
 - Proposed Turbine Locations (SLR L046)
 - ⊕ Proposed Met Mast Location
 - Existing and Proposed Access Track
 - Proposed Infrastructure
 - Existing Borrow Pit
 - Proposed Borrow Pit Search Area
 - 500 m Turbine Buffer (SLR L046)
 - ▲ Existing Turbine Locations
 - Watercourse
 - Automated Bat Detector (SM2) Location 2019
 - Locations with High* Levels of Activity (i.e. > 10 Nights)
 - Bat Activity Driven Transect 2019
- Dusk Transect 25/05/19 - No Passes
- Dusk Transect 03/07/19 (Bat Passes)
- ★ Pipistrellus Pipistrellus (16)
 - Pipistrellus Pygmaeus (1)
- Dawn Transect 23/10/19 (Bat Passes)
- ★ Pipistrellus Pipistrellus (16)
 - Pipistrellus Pygmaeus (6)

Notes
 * High is defined as > 80% of comparable records on the Ecobat database [www.ecobat.org.uk]
