# CLASHINDARROCH II

**Borrow Pit Assessment**  
Prepared for: Vattenfall Wind Power Ltd

Technical Appendix 11.2

Technical Appendix 11.2  
SLR Ref: 405.03640.00011  
Version No: EIA Report  
November 2019

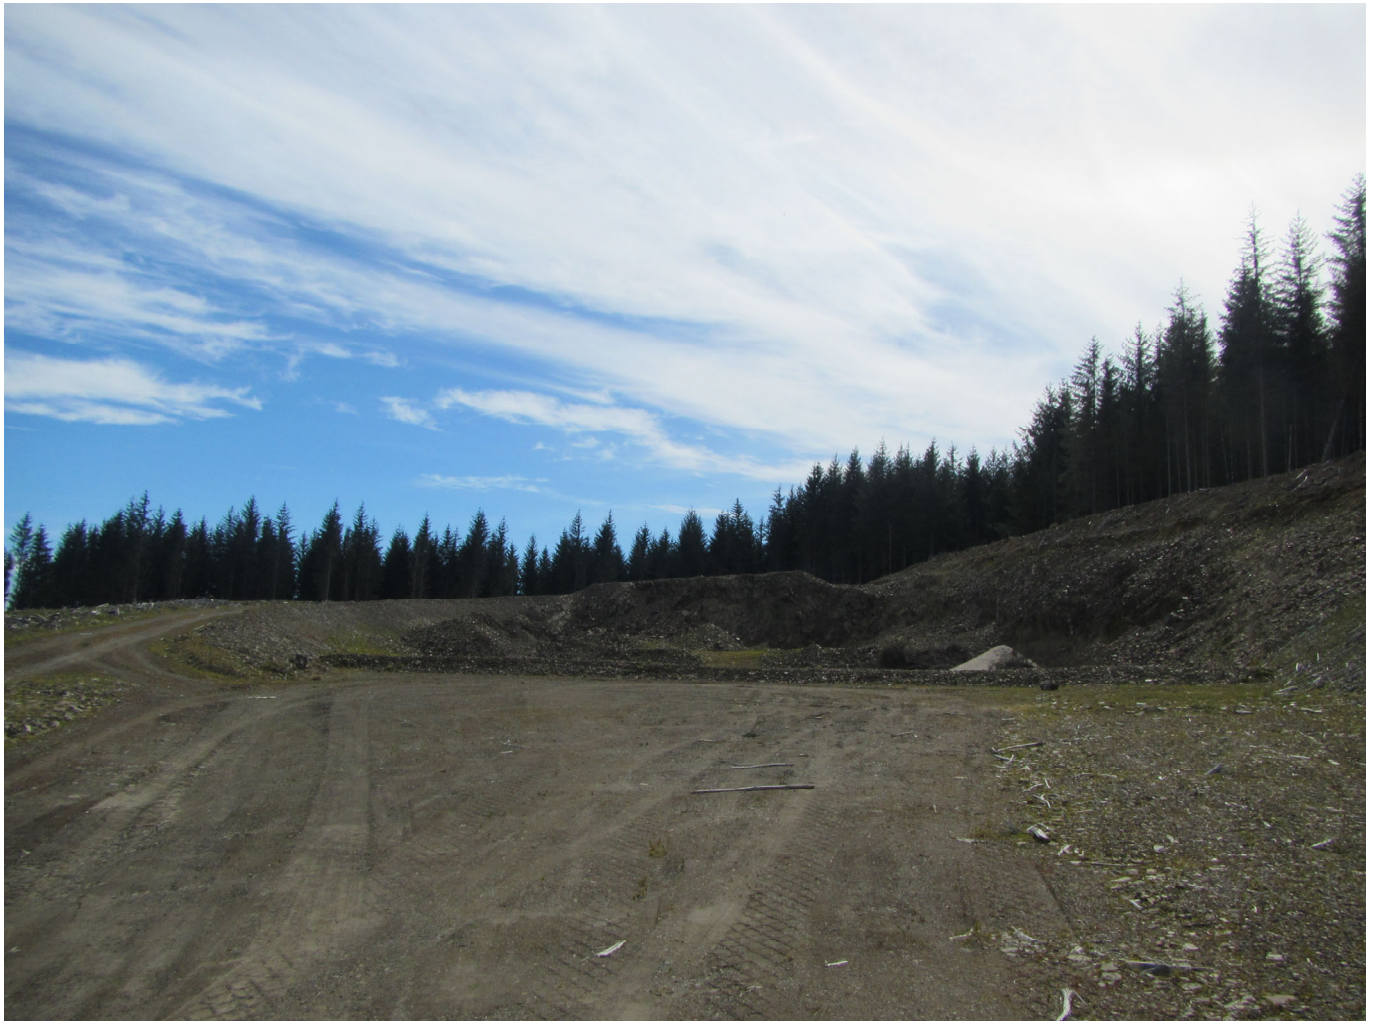
**Photograph 1-1**  
**General View of Ground Conditions at the Existing Borrow Pit Looking South (NGR 251290, 611747)**

31. Photographs of the borrow pit in its operational stage would suggest that the high wall is relatively vertical and therefore this allows a good estimation to be made of volumes of rock that could be extracted from any borrow pit extension.

30. The geological setting of the borrow pit comprises rocks of the Clashindarroch Formation comprising semipelite, pelite, gritty psammite and quartzite. The borrow pit has the potential to be extended to the west.

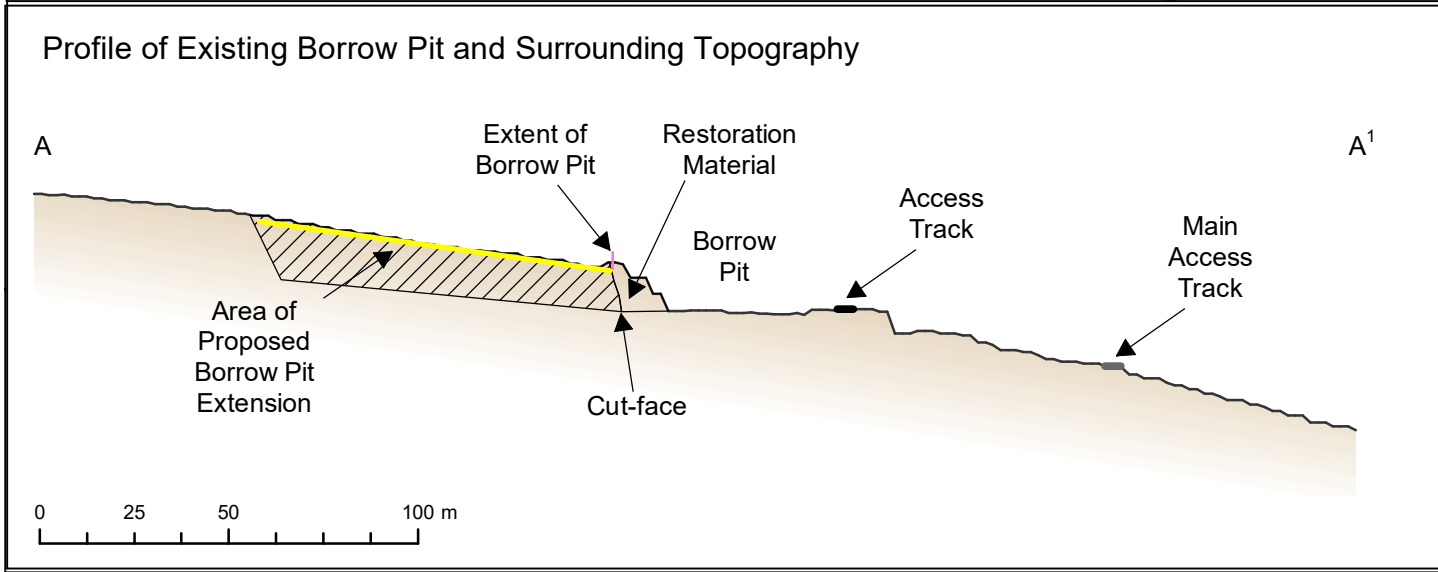
Borrow Pit (NGR 345709, 834516)	
Site Area	Maximum dimensions – Potential Excavation Area 150 m length, 100 m width
Height of Excavation	8-12 m maximum
Area of land impacted*	~15,000 m <sup>2</sup>
Gradient of floor during construction	Slope increases to the west at 1 in 100
Details of Extraction	Combination of ripping and blasting
Overburden type and depth	Restoration soils present from former restoration works. Approximate volume of 10,000m <sup>3</sup> to be removed prior to any extraction. Within the virgin excavation area of the proposed excavation there is limited soil cover, peaty soil less than ~0.2 m but not an extensive cover.
Extent of Aggregate Extraction	An approximate volume of 80,000m <sup>3</sup> of rock depending on excavation depth.
Aggregate Composition	These rocks are described as semipelites.

50. Indicative borrow pit reuse designs is shown in Figure 4. The indicative borrow pit profile has been designed to best utilise the borrow pit based on the previous excavation profiles. Following removal of the overburden material, excavation would commence on the historical high wall, continuing the previous excavation operation. A rectangular shaped excavation has been proposed within the borrow pit in order to meet the estimated requirements for construction materials. Based upon the indicative borrow pit profile a total maximum in situ excavation volume of 144,000m<sup>3</sup> could be achieved.

51. As discussed in section 5.0 above, the total required volume of material is ~116,000m<sup>3</sup>. The borrow pit profile for BP1 is based on a cut of 150m x 100m by a cut depth of 8m, giving a volume of 120,000m<sup>3</sup> as described in Table 1.2.

52. Other primary details and features of the proposed excavation areas include the following:
- The footprint area of the excavation is outlined in Figure 4 for the proposed borrow pit;

- The proposed individual faces would not exceed a gradient of 2 (V) in 1 (H);
  - The borrow pit floor would be excavated to a nominal depth but would in practice would be inclined gently down slope into the pit;

- The maximum height of any single face would be no more than 12.5m; however, based on the current design the maximum total cut would only be ~8m; and
