Quantans Hill Wind Farm Volume 3 - Part 2 Technical Appendices

Quantans Hill Wind Farm

- This is Volume 3 of the EIAR which presents the Technical Appendices associated with the EIAR Chapters.
- Volume 1 of the EIAR presents the 15 Chapters of the EIAR.
- Volume 2a of the EIAR presents the technical Figures associated with the EIAR Chapters except for Chapter • 5 (Landscape & Visual Impact Assessment).
- Volume 2b of the EIAR presents the technical Figures associated with EIAR Chapter 5.
- Volume 2c of the EIAR presents the Visualisations produced for EIAR Chapter 5 and 9 (Landscape & Visual Impact Assessment and Cultural Heritage).
- Volume 4 of the EIAR presents the Non-Technical Summary.

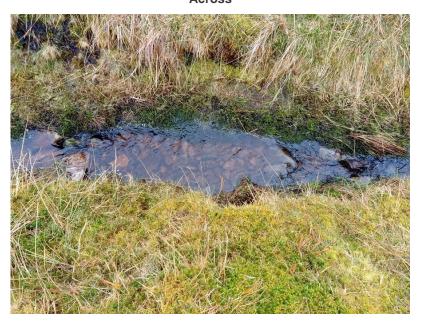
Crossing Photographs Across

WCX2 (257259,593557)		
Crossing Location	Crossing Description	
The second secon	Existing Crossing: No Channel Type: Poorly defined, Incised Gradient: Gentle Valley form: Shallow vee Bank condition: Stable Bed material: Vegetation, Peat Riparian corridor: Moorland, Agricultural Grazing	Water width (m): 0.3 Water depth (m): 0.2 Bankfull width (m): 0.6 Bankfull height (m): 0.7 Banktop height (m): 1.15 Flooded Bankfull width (n Flooded Bankfull height (
75 Nohlegat Nohlegat Application boundary Nohlegat Nohlegat Proposed turbine Cranepad New track Temp Compound Watercourse crossing 0 100 200 300 400 m gat Knowe Watercourse	Flow condition: Moderate	Notes: Probable drainage CAR Auth Level: GBR Proposed Crossing Type
© Crown Copyright 2021. All rights reserved. Ordnance Survey Licence 0100031673.

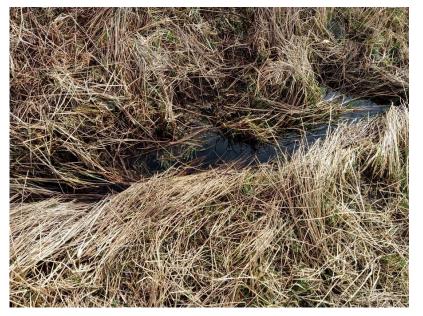
Across

WCX16 (259245,595153)		
Crossing Location	Crossing Description		
the state of the s	Existing Crossing: No	Water width (m): 0.2	
and a star and a star and a star	Channel Type: Incised, Poorly defined	Water depth (m): 0.25	
16 July Alter Street	Gradient: Gentle	Bankfull width (m): 0.3	
17. (117. 117. 117. 350 (117. 10 C	Valley form: Shallow vee	Bankfull height (m): 0.35	
	Bank condition: Stable	Flooded Bankfull width (
17 with the with the	Bed material: Coarse gravel, Boulders, Vegetation	Flooded Bankfull height:	
A ST. ST. ST. ST. ST.	Riparian corridor: Moorland, Agricultural Grazing		
Key	Flow condition: Moderate	Notes: None.	
Application boundary Proposed turbine			
Cranepad		CAR Auth Level: GBR	
New track		Proposed Crossing Type	
Watercourse crossing			
Watercourse Watercourse			
© Crown Copyright 2022. All rights reserved. Ordnance Survey Licence 0100031673.

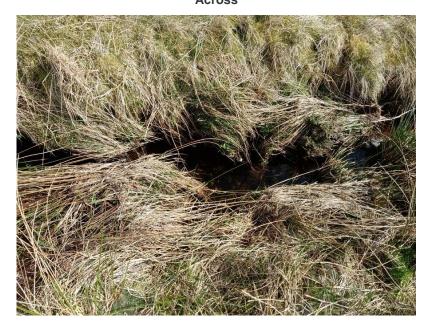
Crossing Photographs Across

WCX18 (259816,594757)		
Crossing Description		
Existing Crossing: No	Water width (m): 0.35	
Channel Type: Incised, Poorly defined	Water depth (m): 0.19	
Gradient: Gentle	Bankfull width (m): 1.1	
Valley form: Shallow vee	Bankfull height (m): 0.55	
Bank condition: Stable, Unstable (potential recent collapse)	Flooded Bankfull width (n	
Bed material: Rounded pebbles, Coarse gravel, Boulders	Flooded Bankfull height:	
Riparian corridor: Moorland		
Flow condition: Moderate	Notes: None.	
	CAR Auth Level: GBR	
	Proposed Crossing Type:	
	 Existing Crossing: No Channel Type: Incised, Poorly defined Gradient: Gentle Valley form: Shallow vee Bank condition: Stable, Unstable (potential recent collapse) Bed material: Rounded pebbles, Coarse gravel, Boulders Riparian corridor: Moorland

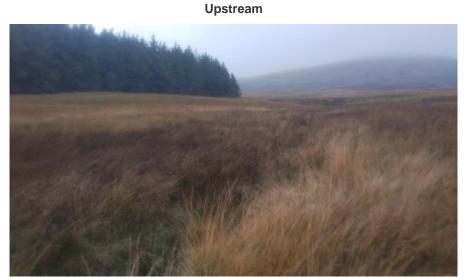
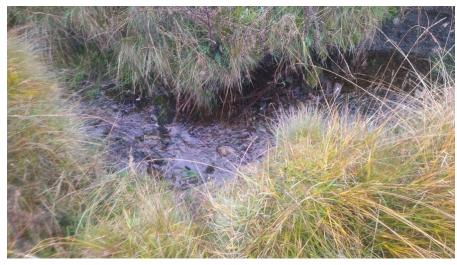
Crossing Photographs

WCX19 (259838,594417)	
Crossing Location	Crossing Description	
	Existing Crossing: No	Water width (m): 1.1
with the second se	Channel Type: Incised, Poorly defined	Water depth (m): 0.1
	Gradient: Gentle	Bankfull width (m): 1.2
The state state state state	Valley form: Shallow vee	Bankfull height (m): 1.5
19	Bank condition: Stable	Flooded Bankfull width (n
Antes antes antes	Bed material: Rounded pebbles, Coarse gravel, Boulders	Flooded Bankfull height (
20 ²⁰ astron	Riparian corridor: Moorland, Heavily Vegetated	
	Flow condition: Moderate	Notes: None.
Sutter atter atter atter atter		CAR Auth Level: GBR
Key		Proposed Crossing Type:
Proposed turbine Watercourse crossing Cranepad Watercourse buffer		
0 100 200 300 m New track Watercourse		
© Crown Copyright 2022. All rights reserved. Ordnance Survey Licence 0100031673.

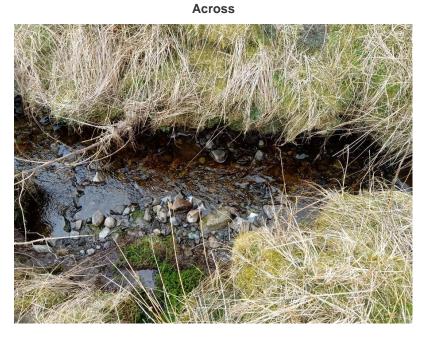
Crossing Photographs

WCX20 (259687,594237)		
Crossing Location	Crossing Description		
	Existing Crossing: No	Water width (m): 0.5	
A solar of the sol	Channel Type: Incised	Water depth (m): 0.1	
TTE COTTER AND COTTER	Gradient: Gentle	Bankfull width (m): 0.5	
The second start with the second start with the second start with the second start	Valley form: Shallow vee	Bankfull height (m): 0.7	
19	Bank condition: Stable	Flooded Bankfull width (
Anter anter anter anter	Bed material: Rounded pebbles, Coarse gravel, Boulders	Flooded Bankfull height	
	Riparian corridor: Moorland, Agricultural Grazing		
Barrier Barrier Control Control Control Control	Flow condition: Moderate	Notes: Probable drainage	
Zunte atter unte the uter uter uter		CAR Auth Level: GBR	
Key		Proposed Crossing Type	
Proposed turbine Watercourse crossing Cranepad Watercourse buffer			
0 100 200 300 m New track Watercourse			
© Crown Copyright 2022. All rights reserved. Ordnance Survey Licence 0100031673.

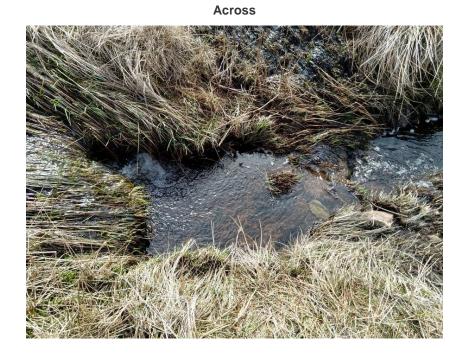
Table 8.1.27: WCX25

WCX25 (260943,593245)	
Crossing Location	Crossing Description	
Crossing Location	Existing Crossing: No Channel Type: Incised, Meandering Gradient: Moderate Valley form: U-shape valley, Concave/bowl Bank condition: Unstable (potential recent collapse) Bed material: Rounded pebbles, Coarse gravel, Boulders, Vegetation, Soil Riparian corridor: Moorland, Agricultural Grazing Flow condition: Fast	g Description Water width (m): 0.8 Water depth (m): 0.1 to 0.7 Bankfull width (m): 0.1 to 0.7 Bankfull width (m): 0.6 (na Bankfull height (m): 0.6 (na Bankfull height (m): 0.4 Banktop height (m): 0.4 Banktop height (m): n\a Flooded Bankfull width (m) Flooded Bankfull height (r Notes: None. CAR Auth Level: Registrati Proposed Crossing Type:
© Crown Copyright 2021. All rights reserved. Ordnance Survey Licence 0100031673.

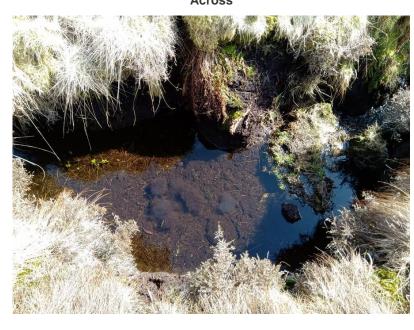
Across

Notes: Some local bank collapse noted with consequential widening. Generally

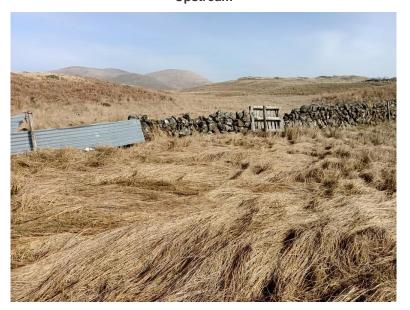
Upstream

Notes: Very poorly defined watercourse. Very slow flow. Difficult to define likely bankfull/flooded widths and heights, these numbers are an estimate and highly uncertain. The channel is boggy ground with only slight flow.

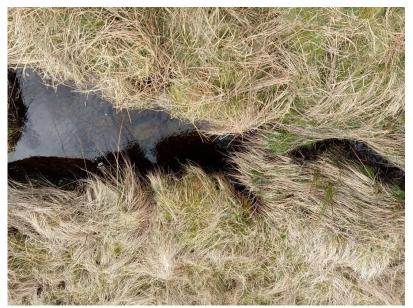
Across

WCX28 (259631,594829)		
Crossing Location	Crossing Description		
the state of the s	Existing Crossing: No	Water width (m): 0.25-0.8	
with a star and a star	Channel Type: Incised	Water depth (m): 0.18	
16 July with the star	Gradient: Moderate	Bankfull width (m): 0.85	
atter with a contractor of the	Valley form: Shallow vee	Bankfull height (m): 0.6	
	Bank condition: Stable	Banktop height (m): n\a	
17 with the terms of the	Bed material: Fine sand/silt, Rounded pebbles, Coarse gravel, Boulders	Flooded Bankfull width (n	
STATUSTA STATUSTA	Riparian corridor: Moorland	Flooded Bankfull height (
Key	Flow condition: Moderate		
Application boundary Proposed turbine		Notes: Probable drainage	
Cranepad 6,18			
New track		CAR Auth Level: GBR	
Watercourse crossing Watercourse buffer		Proposed Crossing Type:	
Watercourse 0 100 200 300 m			
© Crown Copyright 2022. All rights reserved. Ordnance Survey Licence 0100031673.

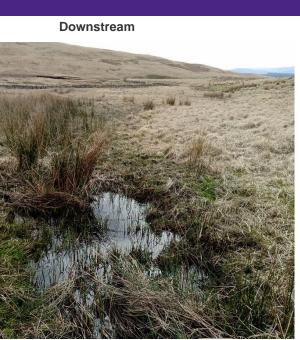
Notes: Very poorly defined watercourse. boggy ground immediately east of

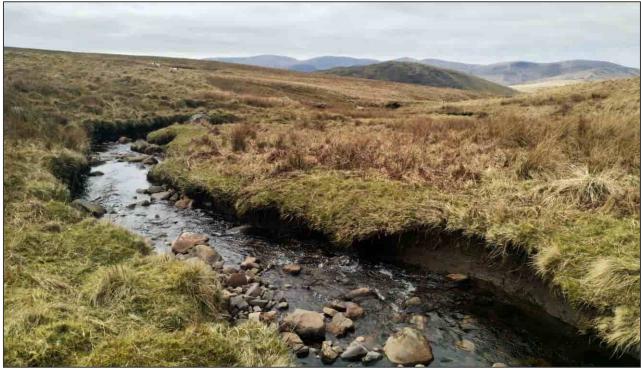
Figure 1.4: Typical example of incised watercourse showing limited peat and underlying glacial sub-soils

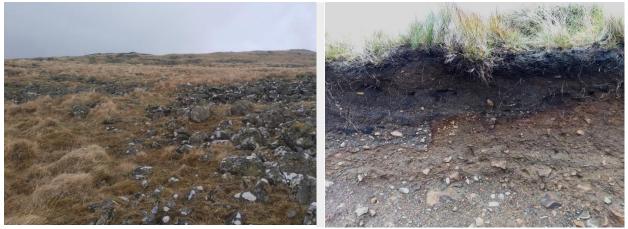
Photographs A8.1: Photographs obtained during peat surveys at Quantans Hill. The left shows boulder strewn ground near Furmiston Craig. The right photo shows a soil exposure near Knockwhirn demonstrating matrix support glacial subsoil with an organic soil horizon above

- A8.4.9. Table A8.4.2 demonstrate that the peat deposits at the Proposed Development are generally characterised as soft to very soft, dark brown, pseudofibrous (occasionally amorphous), plastic peat with Von Post classification codes ranging from H2 to H7. There were very few natural exposures of the peat identified during the surveys. Photos collected at a few locations are presented in Photographs A8.1 below.

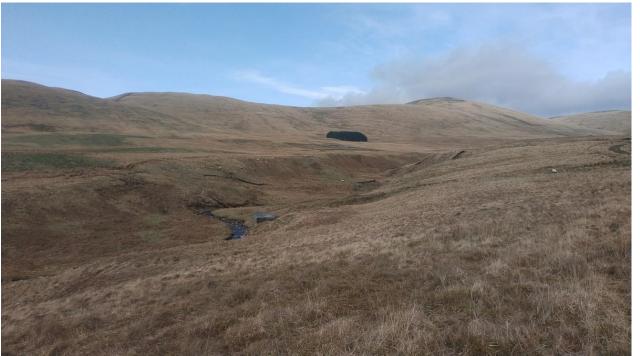
Figure 1: Photograph of the Benloch Burn catchment demonstrating the upland moorland character of the Proposed Development area.

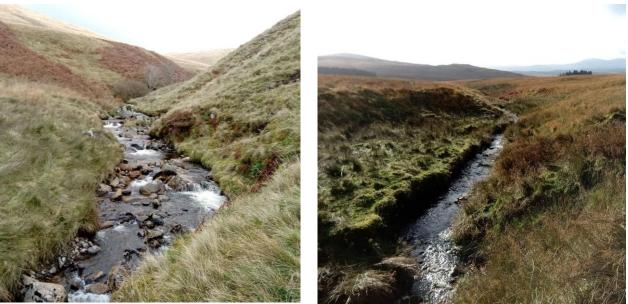
Photo 5.1: Photographs illustrating the typical morphology of the watercourses situated within the **Proposed Development**

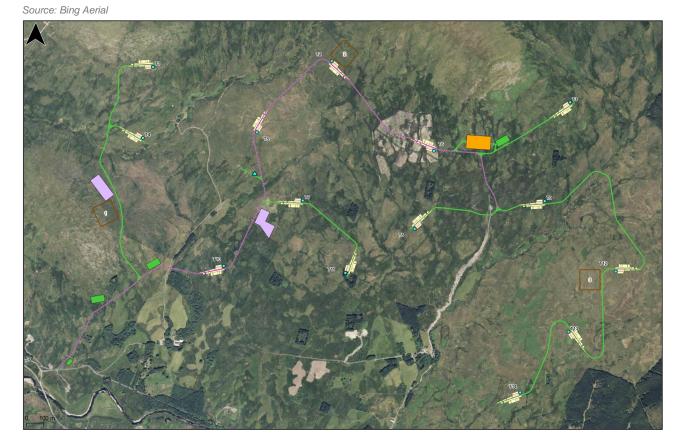
Figure 4.1: Borrow Pit Search Area Locations 1-3

Three-potential borrow pit search areas have been identified as part of this study, as shown in Figure 4.1 below.

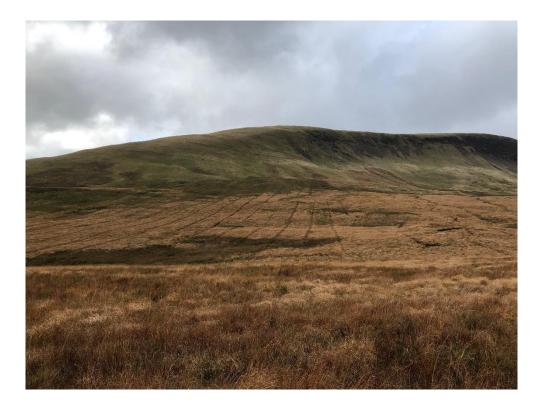
Plate 3: View of drainage ditches in northern portion of the Proposed Development Area

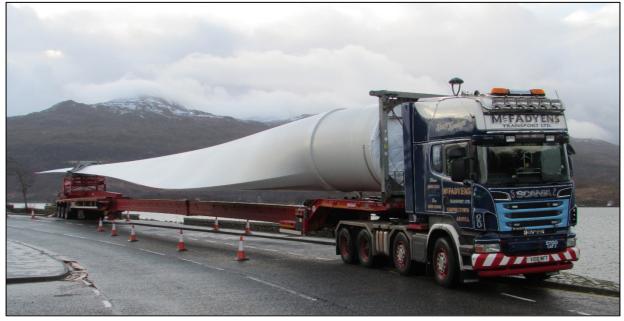
Figure 3: Tower Trailer

Examples of the types of trailer are illustrated in Figures 2 and 3 below.

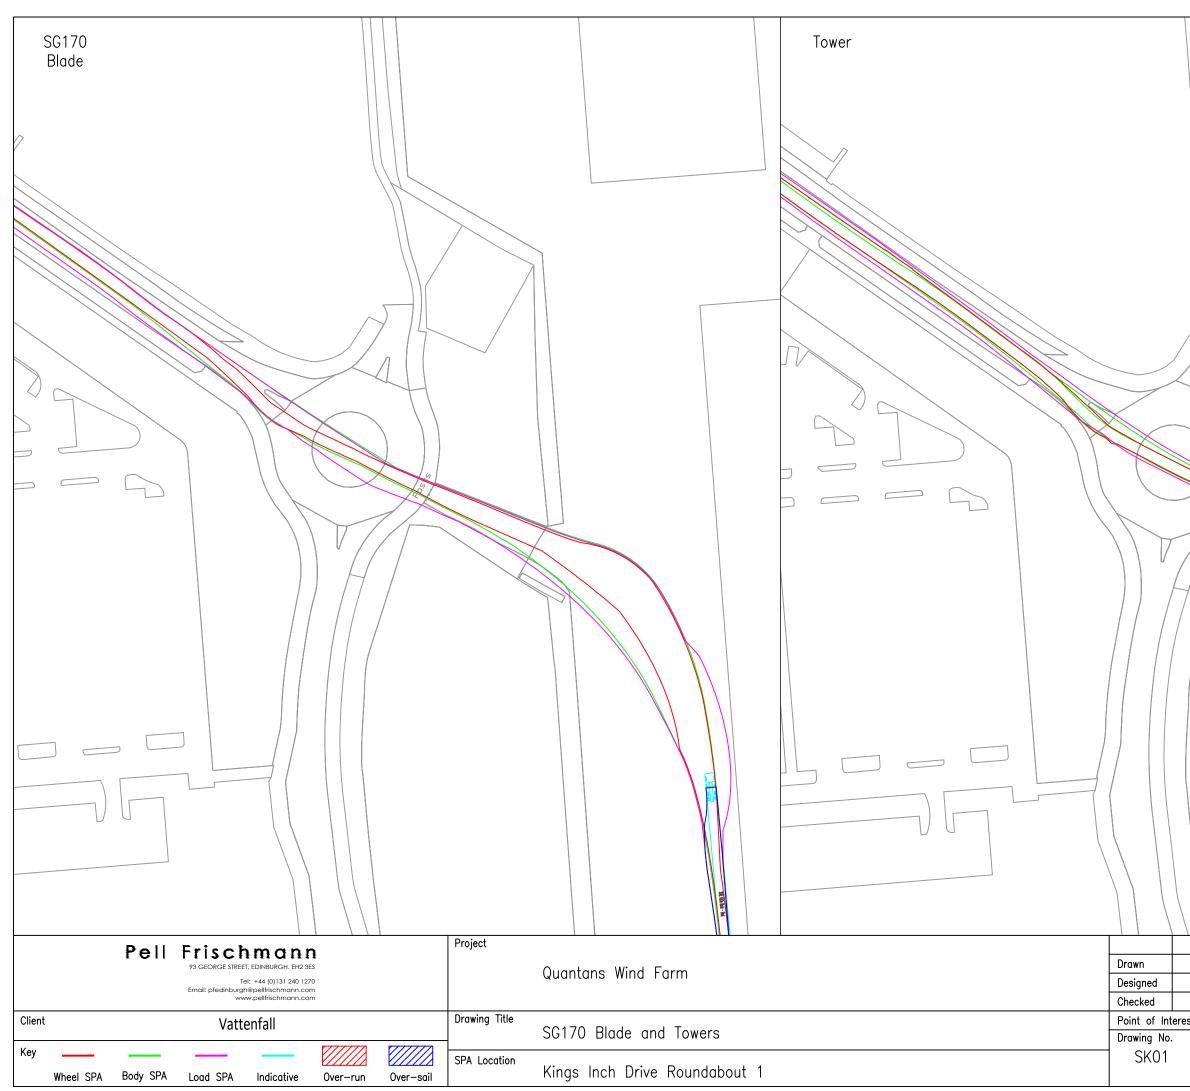
Appendix B Swept Path Assessments

A		
$ \land $		
[[[
		© Pell Frischmann
Name JS	Date 24/11/21	1:1000 @ A3
GB	24/11/21	File No. Quantans SPA (FINAL).dwg
GB	24/11/21	Drawing Status
est	1	Draft
Notes: 1. All mitiga 2. This is n	tion is subject to c ot a construction dr	onfirmation through a test run. awing and is intended for illustration purposes only.

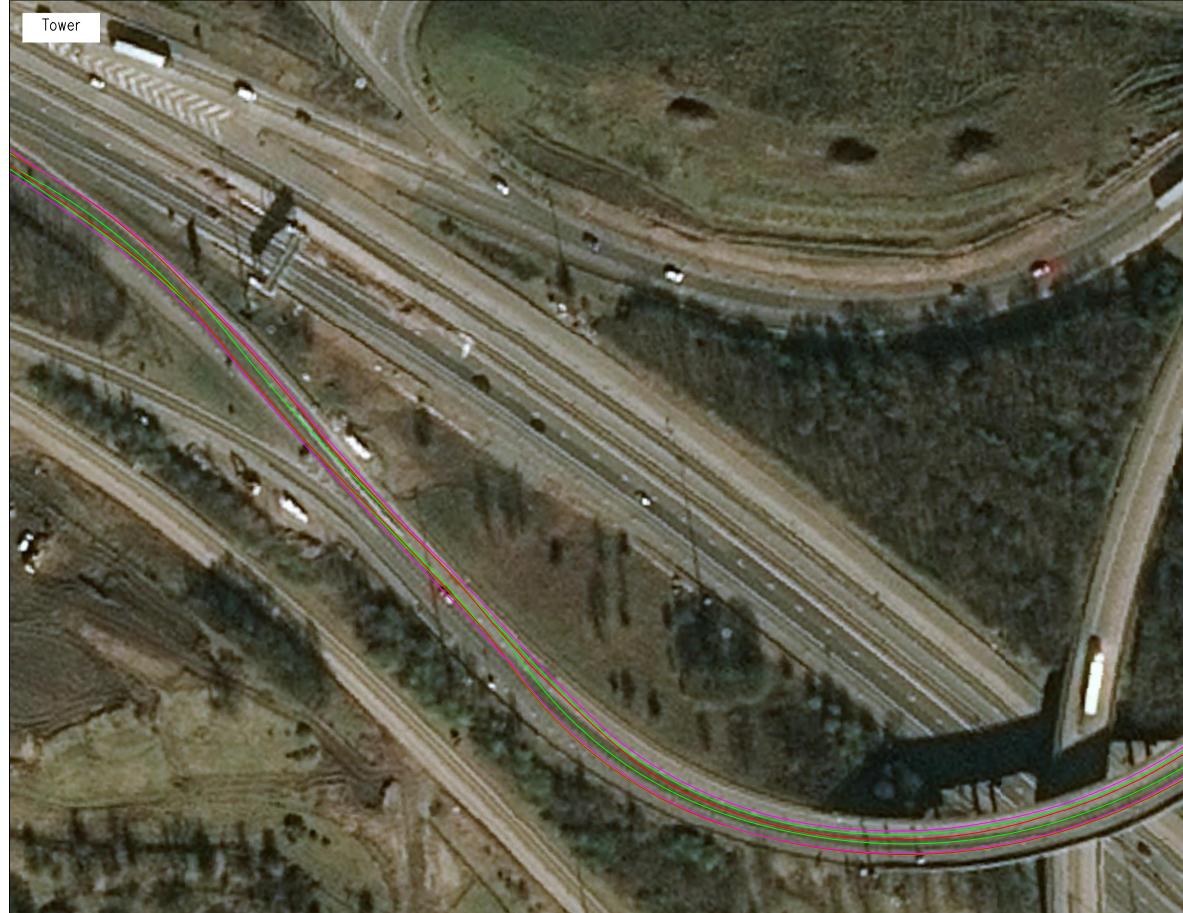
Pell	Frisch	hman	n		Project			
		1 011		ET, EDINBURGH. EH2 3				Quantans Wind Farm		
	Tel: +44 (0)131 240 1270 Email: pfedinburgh@pellfrischmann.com								Designed	
				ww.pellfrischmann.co					Checked	
Clien	Client Vattenfall						Drawing Title	SG170 Blade and Towers NO MITIGATION REQUIRED	Point of Int	ter
							-	SG170 Blade and Towers NO MILIGATION REQUIRED	Drawing No.	
Key							SPA Location		SK06A	١
	Wheel SPA	Body SPA	Load SPA	Indicative	Over-run	Over-sail		M73 / M74 Bend

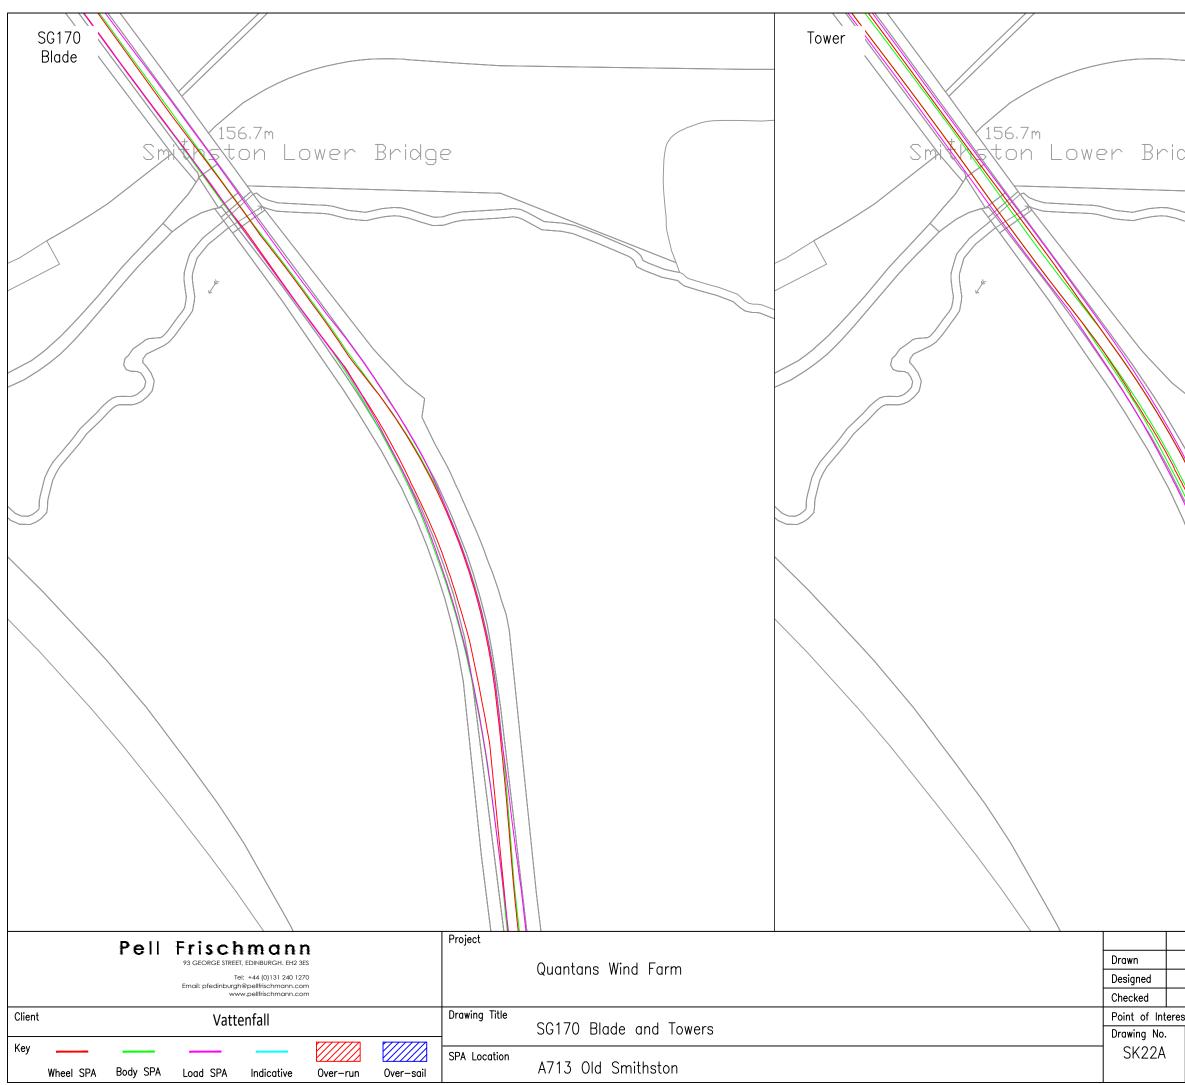
and on	nevron sign ne utility pole removed.	Load bearing surfa be laid. Drainage to be culverted. Vegetation to be co Traffic bollards and chevron sign to be removed.	ditch leared. d one
Pell Frischmann 93 George street, edinburgh, eH2 3es	Project Quantans Wind Farm	Drawn	Name         Date           JS         24/11/2           OD         24/11/2	
Tel: +44 (0)131 240 1270 Email: pfedinburgh@pellfrischmann.com www.pellfrischmann.com		Designed Checked	GB 24/11/2	1 Prie No. Quantans SPA (FINAL).dwg 1 Drawing Status Draft
Client Vattenfall	Drawing Title SG170 Blade and Towers	Point of Intere Drawing No.	est 26 Notes:	Revision
Key Wheel SPA Body SPA Load SPA Indicative Over-run Over-sail	SPA Location A713 Bends near Smithston	SK21B	2. This is not a construction	o confirmation through a test run. I drawing and is intended for illustration purposes only. 1

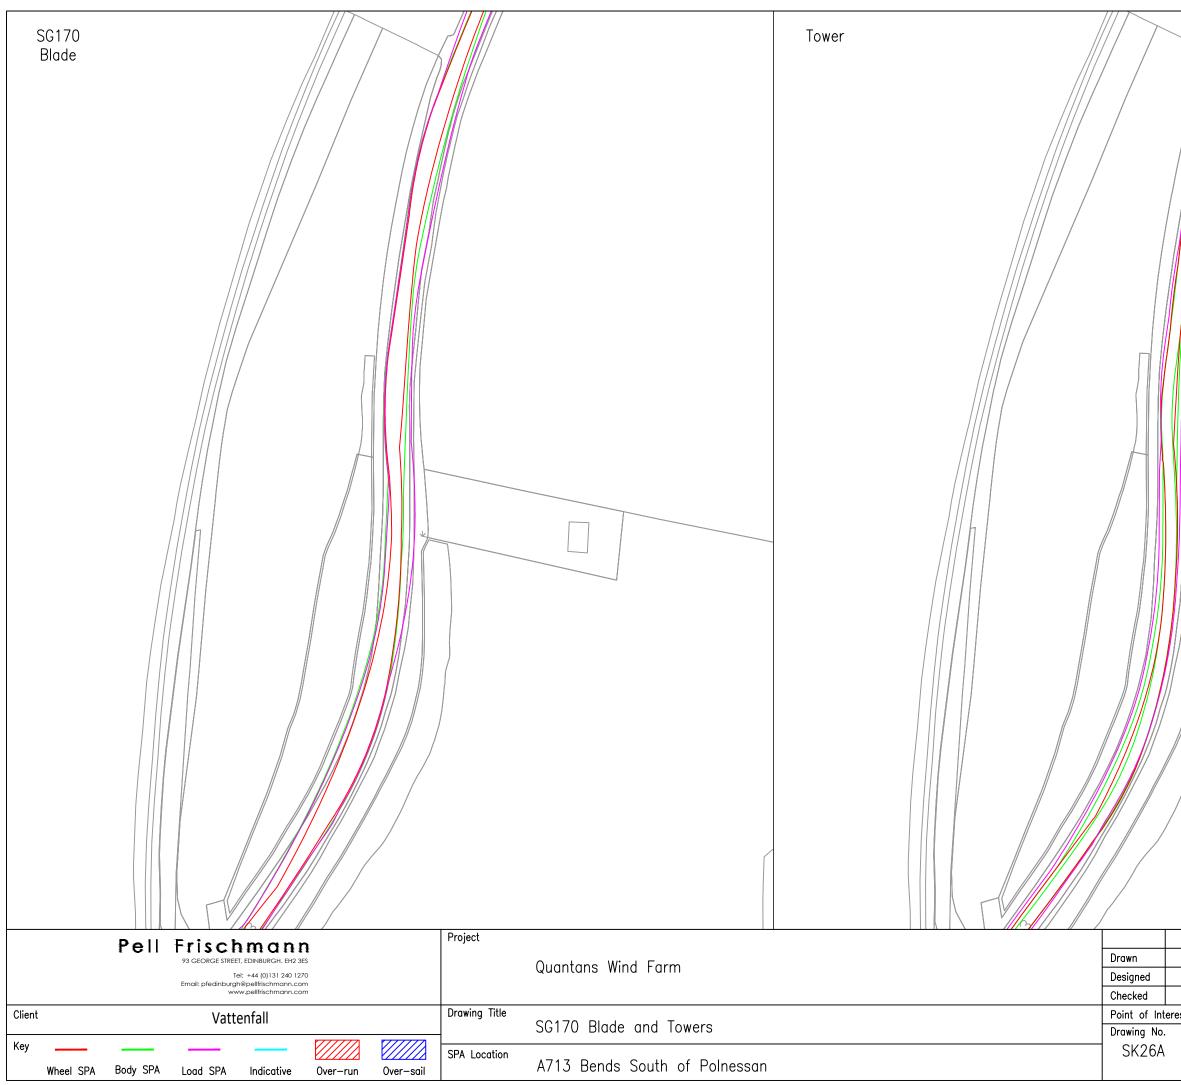
Blade tip to oversail the traffic bollards.					
	Project				Name	Date Scale		) Pell Frischmann
Pell Frischmann 93 GEORGE STREET, EDINBURGH, EH2 3ES Tel: +44 (01131 240 1270		Quantans Wind Farm		Drawn	JS	Date         Scale           24/11/21         File No.	##### @ A3	
Tel: +44 (0)131 240 1270 Email: pfedinburgh@pellfrischmann.com www.pellfrischmann.com				Designed Checked	GB GB	24/11/21 Drawing	Quantans SPA (FINAL) Status	
Client Vattenfall	Drawing Title	SG170 Blade and Towers		Point of Inter Drawing No.	Notes:	30	Diart	Revision
Key Wheel SPA Body SPA Load SPA Indicative Over-run Over-sail	SPA Location	A713 Polnessan		SK25B	1. All mitig 2. This is	gation is subject to confirmation thr not a construction drawing and is i	ough a test run. ntended for illustration purposes only.	1

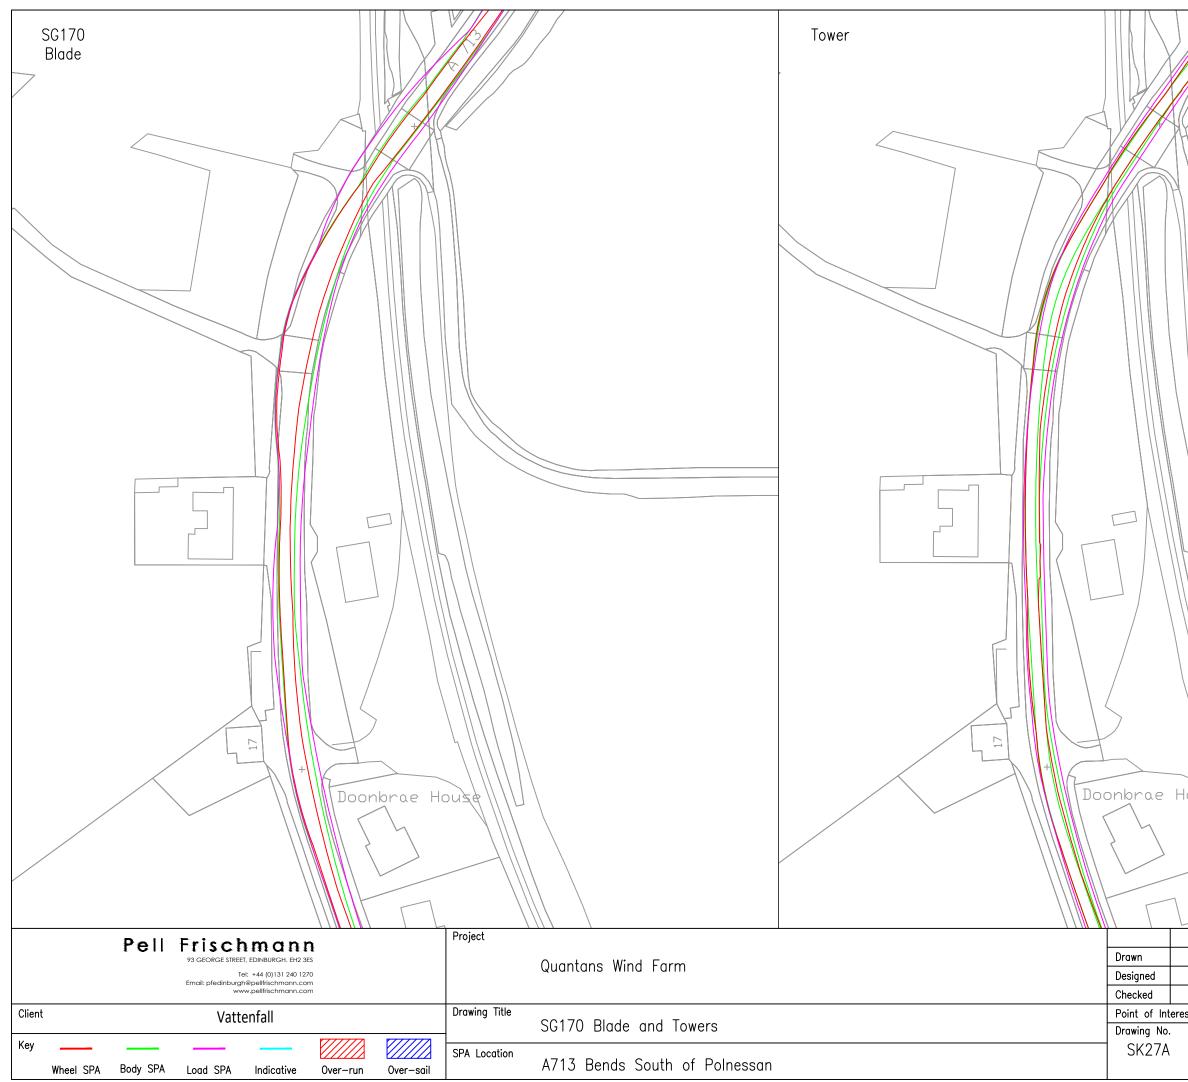
One lighting column should be removed. Load bearing surface should be laid in overrun areas. One lighting column should be removed.	Doonbro	ae Hous				
Pell Frischmann	/ Project			Name	Date	Scale	###### @ A	© Pell Frischmann
93 GEORGE STREET, EDINBURGH, EH2 3ES		Quantans Wind Farm	Drawn	JS	24/11/21	File No.		
Tel: +44 (0)131 240 1270 Email: pfedinburgh@pellfrischmann.com www.pellfrischmann.com			Designed		24/11/21	QL	uantans SPA (FIN	IAL).dwg

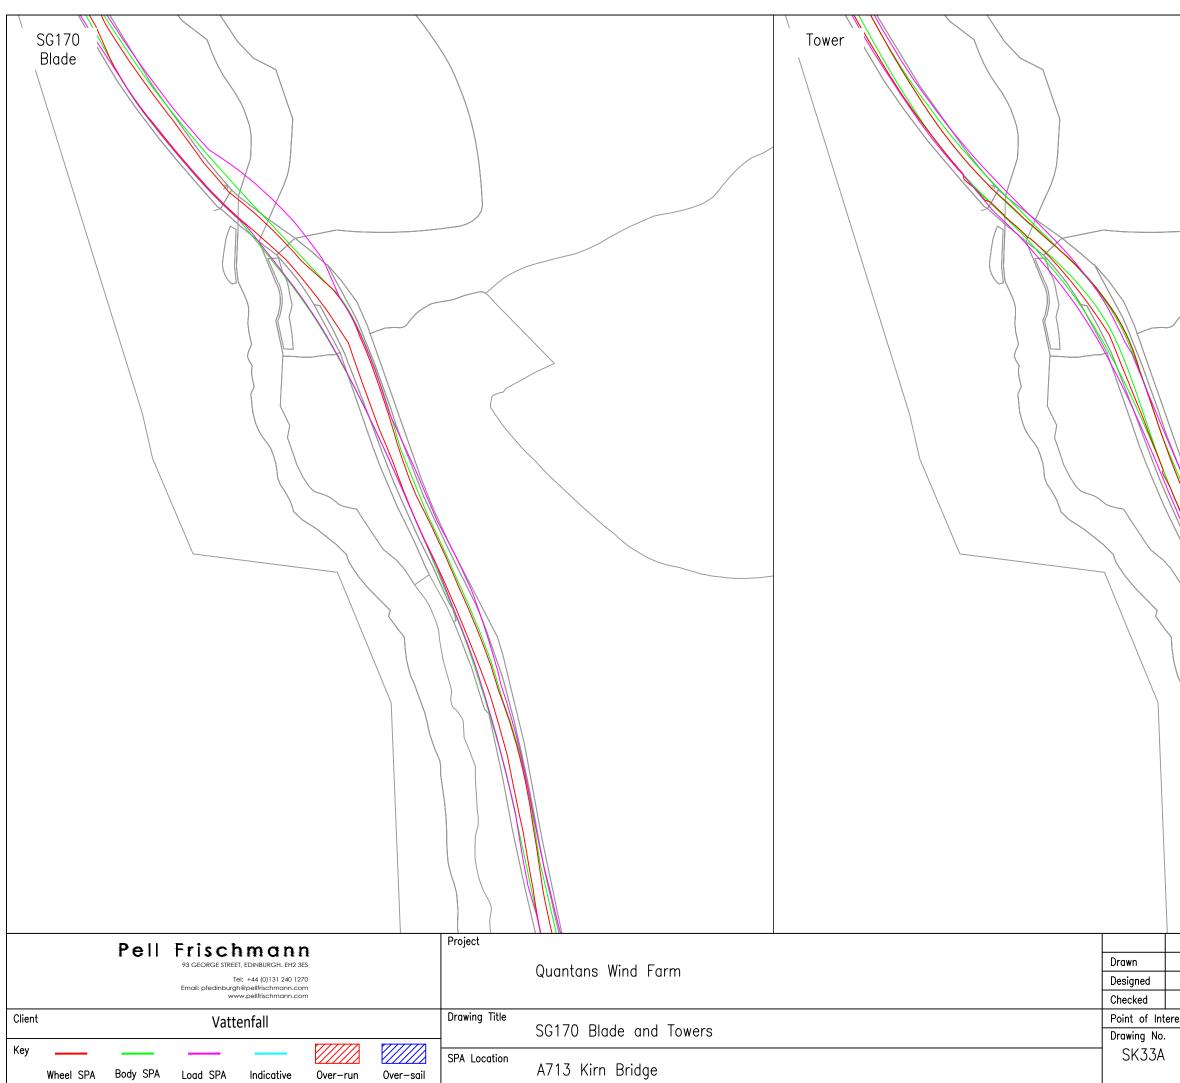
Loads over run . chevr
		Topographical survey required to confirm suitability of load	
		over-sail.	
Topographical survey required. Swept path assessment to be repeated.			
Pell Frischmann	Project		
93 GEORGE STREET, EDINBURGH. EH2 3ES Tel: +44 (0)131 240 1270 Email: pfedinburgh@pellfrischmann.com		Quantans Wind Farm	Drawn Designed
Client Vattenfall	Drawing Title		Checked Point of Interes
Key /////	SPA Location	SG170 Blade and Towers	Drawing No. SK33B
Wheel SPA Body SPA Load SPA Indicative Over-run Over-sail	SPA LOCUTION	A713 Kirn Bridge
