Aultmore Wind Farm Redesign

Technical Appendix 10.4: Water Course Crossing Assessment

Vattenfall Wind Power Ltd

SLR Project No.: 405.V3640.00016

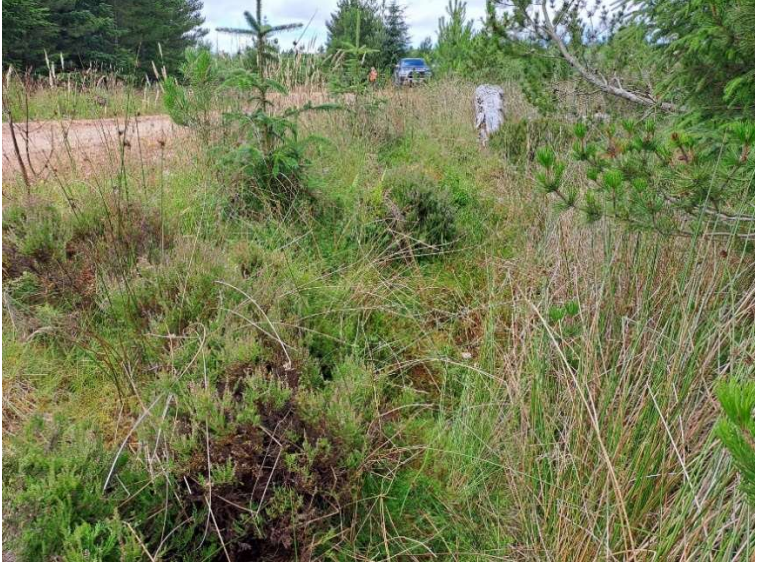
Watercourse Crossing ID	WX01
Watercourse Crossing Details	<p>E/N: E346693, N859976</p> <p>Status: Existing</p> <p>Culvert Diameter: 0.3m</p> <p>Culvert Construction Type: Plastic circular culvert</p> <p>Watercourse Width: up to 0.5m</p> <p>Watercourse Depth: 0.01m</p> <p>Notes: Stagnant water with no clear channel upstream. Culvert is heavily vegetated and is noted to be 0.5m below the road surface. Unable to find culvert entrance upstream due to vegetation.</p>
Photograph Looking at Culvert Entrance from Upstream

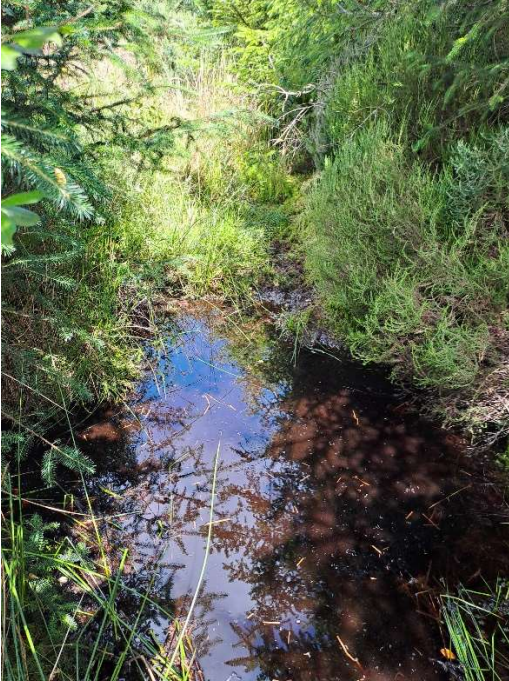
Watercourse Crossing ID	WX02
Watercourse Crossing Details	<p>E/N: E346920, N859901</p> <p>Status: Existing</p> <p>Culvert Diameter: 0.5m</p> <p>Culvert Construction Type: Concrete circular culvert</p> <p>Watercourse Width: up to 1m</p> <p>Watercourse Depth: 0.4m</p> <p>Notes: No clear channel upstream, water has ponded from road drainage. Heavily vegetated.</p>
Photograph Looking at Culvert Entrance from Upstream

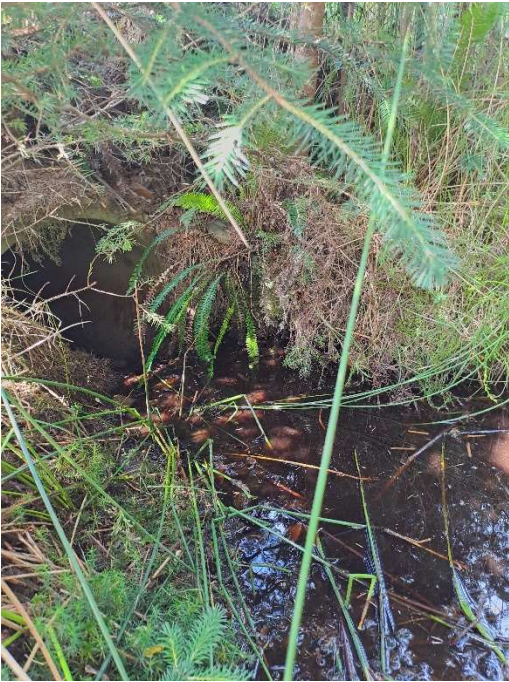
<p>A photograph showing a narrow, shallow watercourse heavily overgrown with dense green vegetation, including ferns and grasses. The water is dark and still, reflecting the surrounding foliage. The culvert entrance is partially obscured by the thick growth.</p>
Photograph Looking at Culvert Exit from Downstream

<p>A photograph showing the exit of the culvert into a watercourse. The water is dark and surrounded by dense, tall green vegetation, including ferns and grasses. The culvert exit is visible as a narrow opening in the dense growth.</p>

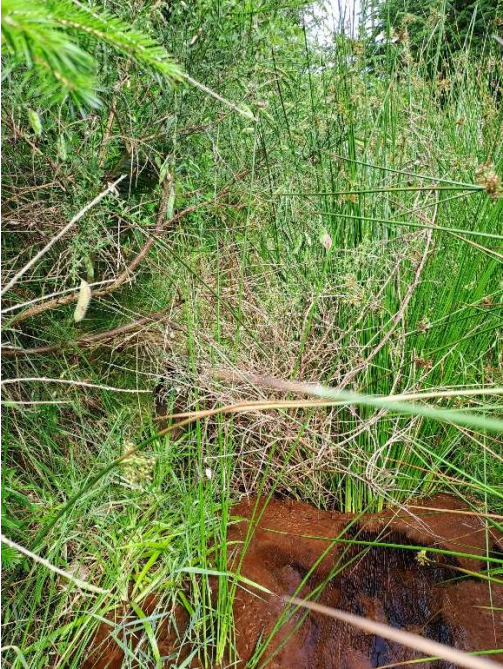
Watercourse Crossing ID	WX03	
Watercourse Crossing Details	<p>E/N: E346867, N859782</p> <p>Status: Existing</p> <p>Culvert Diameter: 0.5m</p> <p>Culvert Construction Type: Concrete circular culvert</p> <p>Watercourse Width: 0.2m</p> <p>Watercourse Depth: 0.4m</p> <p>Notes: Culvert up to 2m below road level. Stagnant water with evidence of ponding containing peaty sediments. Heavily vegetated.</p>	
Photograph Looking at Culvert Entrance from Upstream

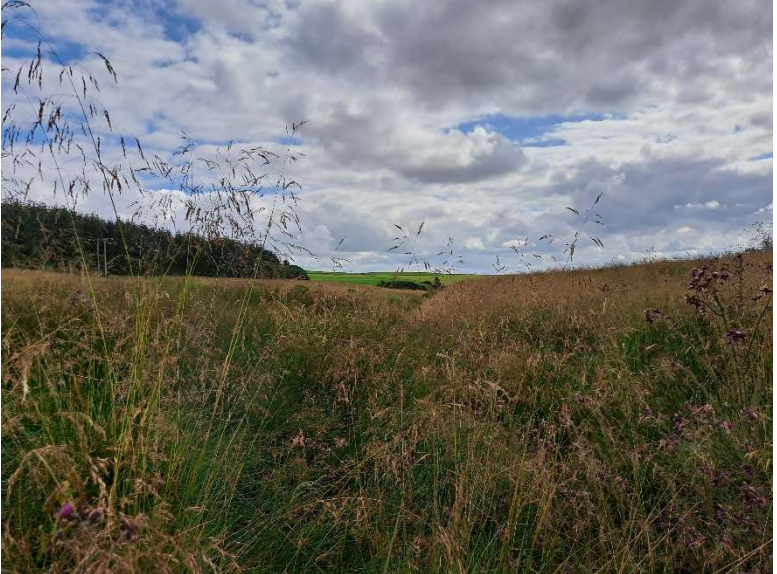
Watercourse Crossing ID	WX05
Watercourse Crossing Details	<p>E/N: E340458, N856555 Status: New Watercourse Width: 0.2m Watercourse Depth: 0.1m Notes: Located within a deeper channel measuring 0.8m wide.</p>
Photograph Looking Upstream	 
Photograph Looking Downstream

Potential Crossing Type Likely Required CAR Authorisation	Culvert Registration

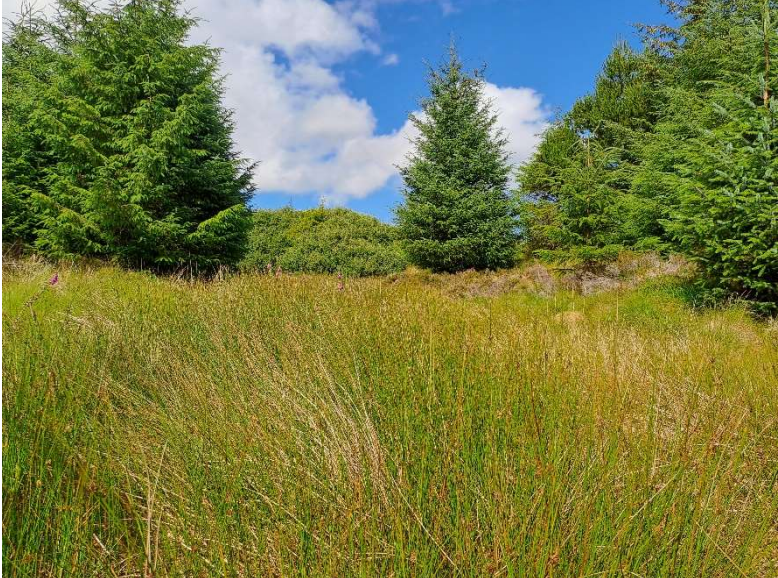
Watercourse Crossing ID	WX07
Watercourse Crossing Details	<p>E/N: E345659, N859152 Status: New Watercourse Width: 0.2m Watercourse Depth: 0.2m Notes: Located within a deeper channel measuring up to 1m wide.</p>
Photograph Looking Upstream

Potential Crossing Type Likely Required CAR Authorisation	Culvert Registration
